Project #: 24-0695

Green Cottage  
Maynooth, Ontario

**SUBJECT: REPORT ON GEOTECHNICAL SLOPE STABILITY AND FOUNDATION ASSESSMENT FOR A PROPOSED GARAGE STRUCTURE, 1995 MINK LAKE ROAD, MAYNOOTH, ONTARIO.**

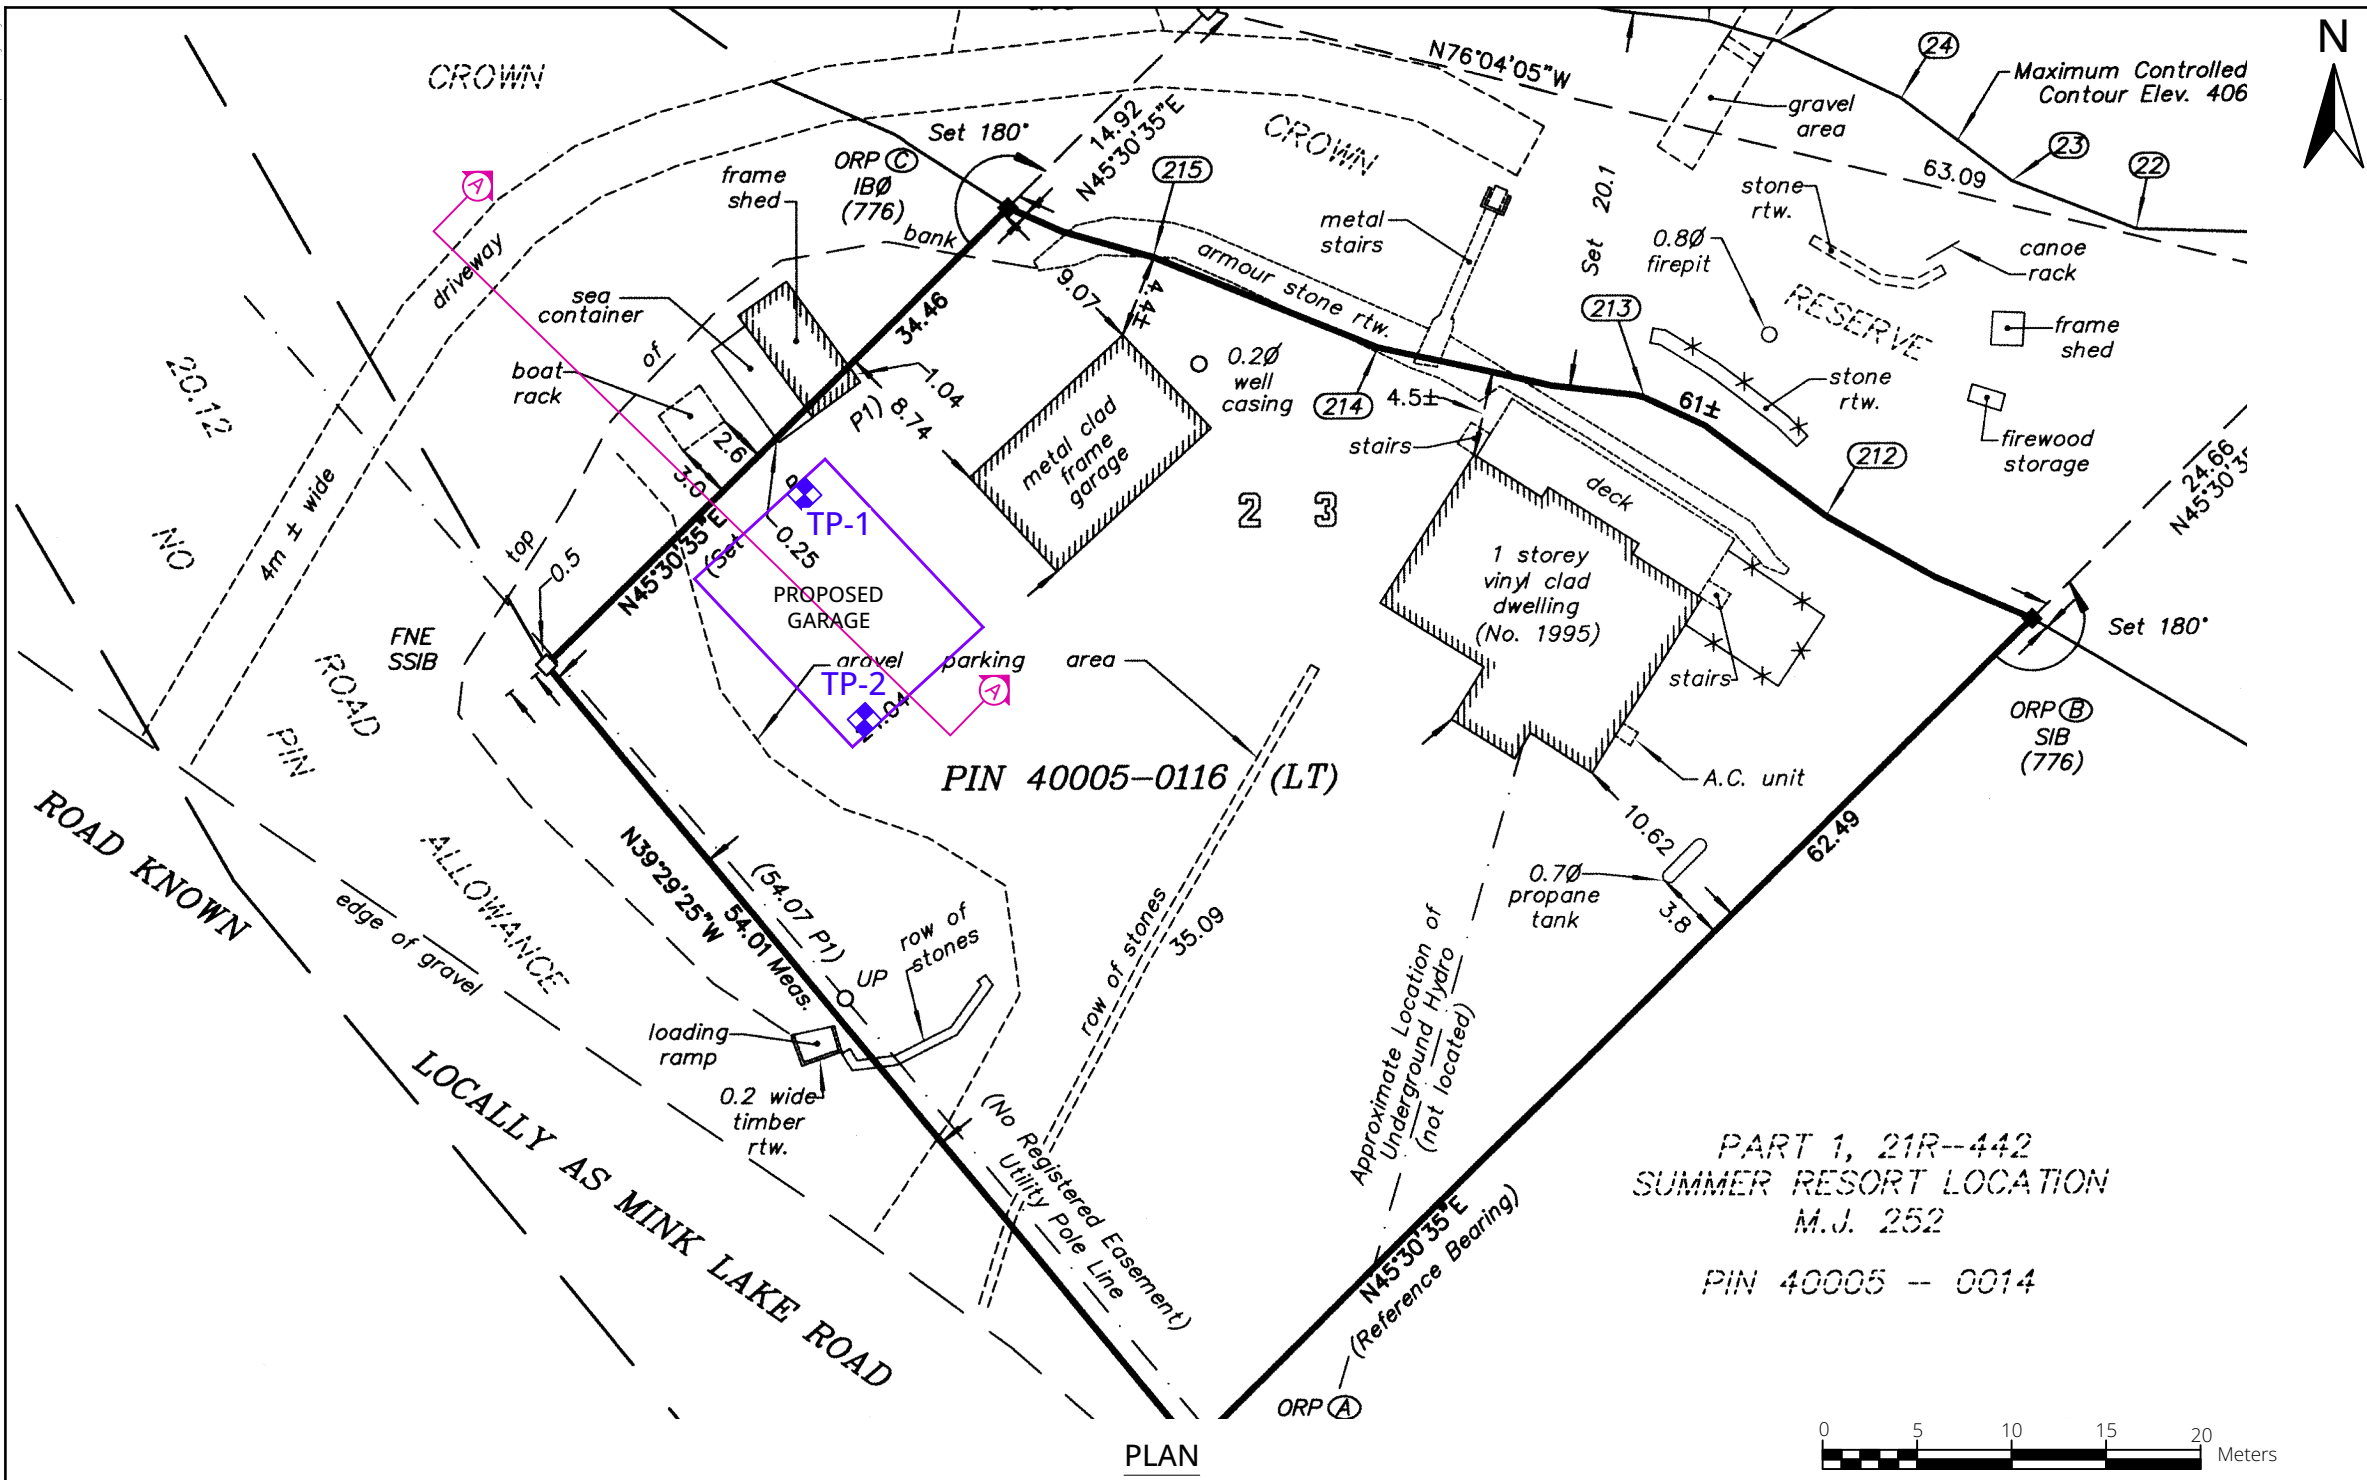
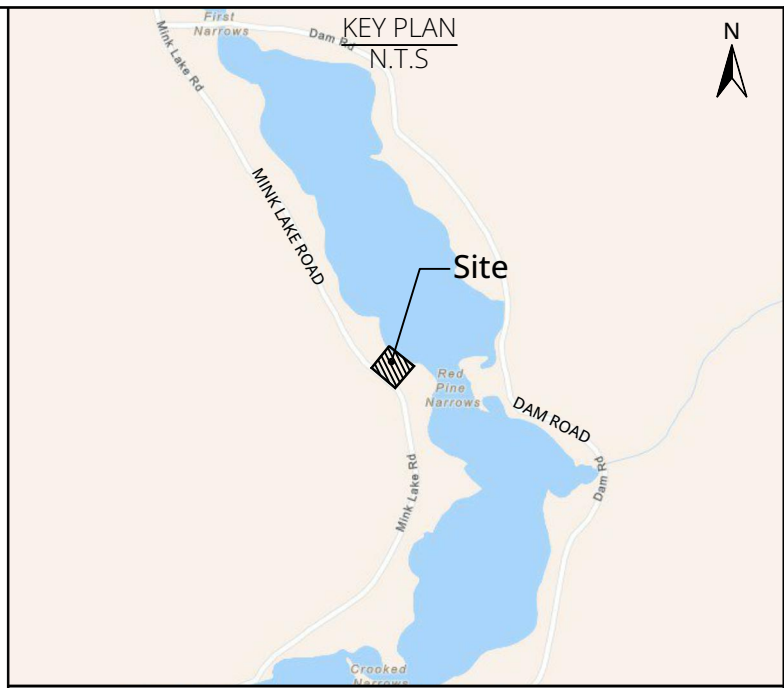
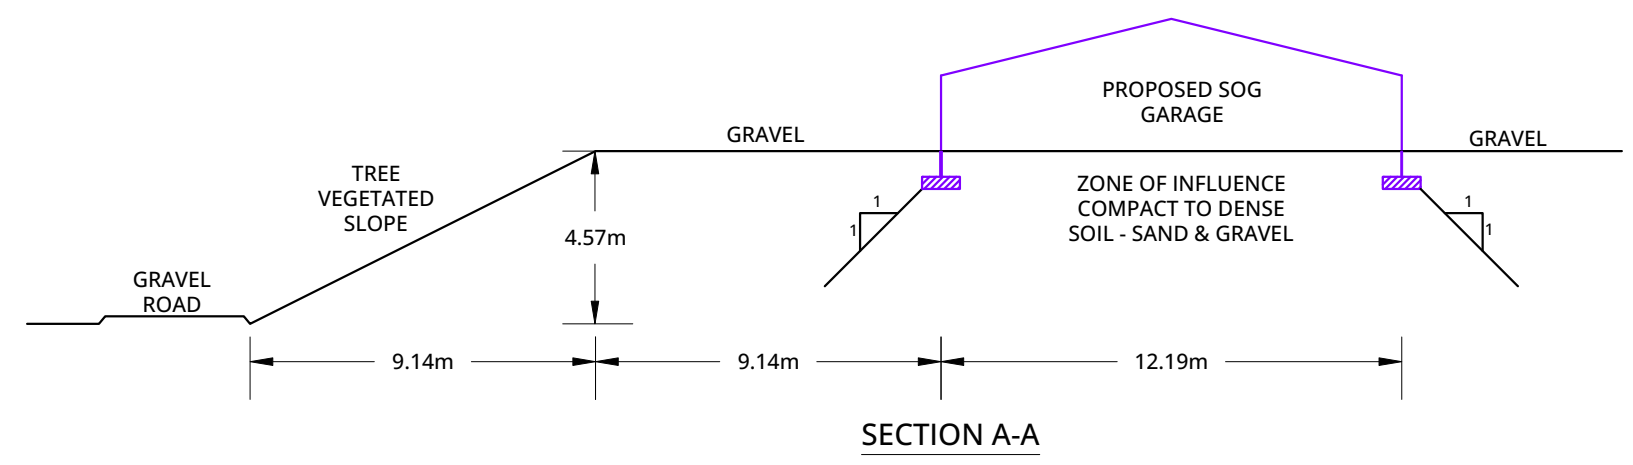
TITLE Testpit & Proposed Garage Location Plan and Section A-A				
PROJECT 1995 Mink Lake Road Hastings Highlands, ON				
CLIENT Green Cottage				
PROJECT NO. 24-0695	DATE May, 2024	PREPARED BY ZMO	APPROVED BY DL	FIGURE NO 1

The approximate testpit locations are shown in **Figure No. 1**. The subsurface conditions are also presented in Figure 1 and are summarized in the following paragraphs.

The area designated for the New Garage Structure is currently a large relatively flat gravel parking area with a sand and gravel base. Visual inspection and testpits revealed an upper sand and gravel fill across the entire area in question. Fill depth ranged from 0.3m to 0.8m (east to west) across the proposed building envelope.

The fill layer was found to be underlain by potential glacial deposit of silty sand with some gravel, extending to testpit termination at approximately 1.4mbelow grade. Based on probing observations, these deposits are considered to be in a compact to dense state. Water contents in the silty sand and gravel is expected to be moist, in the range of 6 to 9%.

Slope stability was assessed with consideration of X-section and setbacks from the field survey. The closest distance from the building to the observed top of bank is 9m followed then by an embankment with a 4.5m drop to the gravel access road below. This survey also made note of the vegetated slope with deep rooted trees and brush which provides for a generally stable bank in the area to the west and south of the existing parking area where the garage is proposed.

The evaluation of soil types, with particular interest of the native founding dense glacial silty sand and gravel till allows for a confident estimation of the zone of influence that the structure will have within the bearing soils below and laterally from the structure foundations (see Figure 1). With consideration of the native soil material, a 1:1 slope down and laterally from the foundation would best define the structures zone of influence loading and this loading would not have an impact adjacent slope stability.

0.00 - 0.84 m FILL - BROWN SAND & GRAVEL, MOIST, COMPACT  
 0.84 - 1.37 m NATIVE - RED BROWN SILTY SAND WITH SOME GRAVEL, MOIST, DENSE

0.00 - 0.30 m FILL - BROWN SAND & GRAVEL, MOIST, COMPACT  
 0.30 - 1.37 m NATIVE - BROWN SILTY SAND AND GRAVEL, SOME SILTY SAND SEAMS, MOIST, DENSE

Garage foundations must be founded in the native, dense silty sand and gravel material found at a depth that ranged from 0.3 to 0.8m below existing parking lot grade.

Based on the assessment of setback distances, slope height, slope vegetation and founding soil materials, the proposed structure will have no impact on the stability to the slopes that are adjacent to the structure. Soil grading around the structure and management of water run-off from roof surfaces and surrounding parking surfaces should be considered in the final design and landscaping to avoid potential erosion from occurring in this general area.
