Summary Action Report Boulter Road Bridge

Inspection Date October 19, 2023

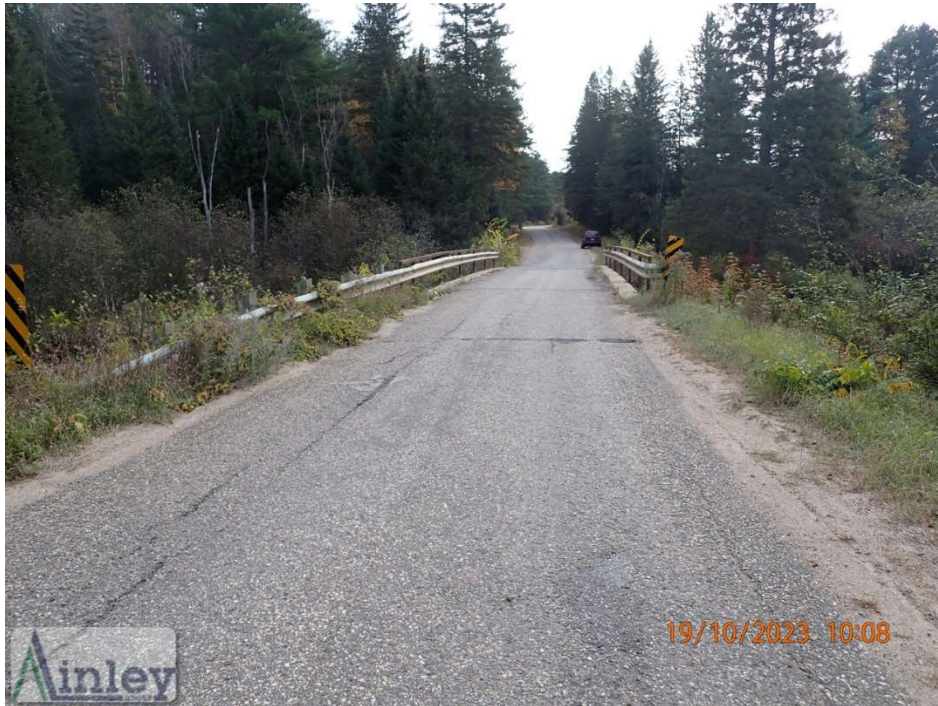
Photo 3: North Approach Looking at Structure – Medium Ravelling, Patched Potholes, Localized Severe Longitudinal and Transverse Cracks

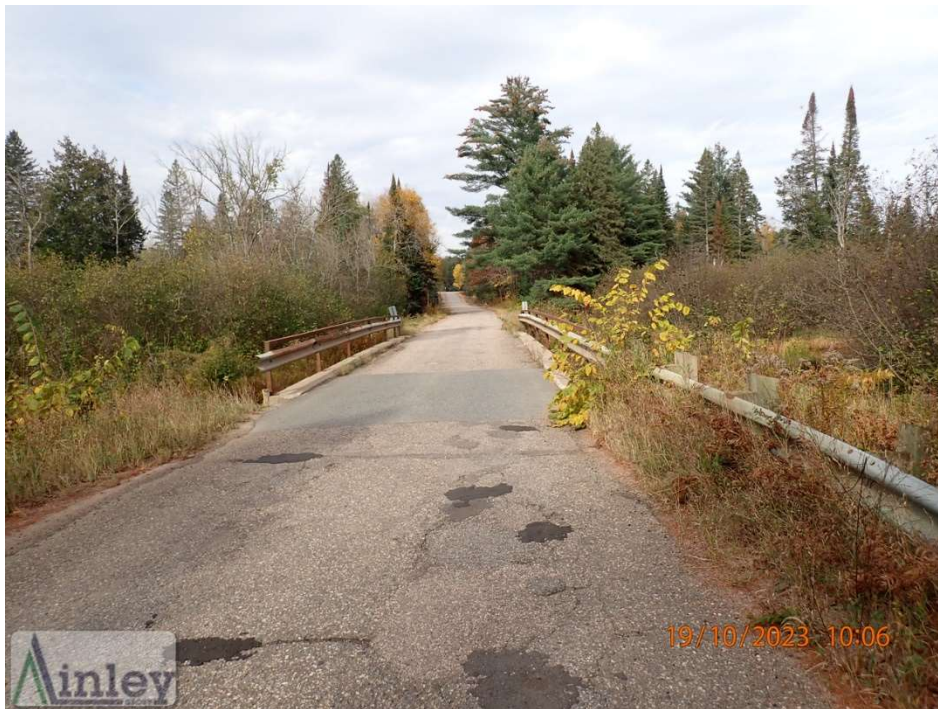
Photo 4: South Approach Looking at Structure – Medium Ravelling, Patched Potholes, Light to Medium Cracks Throughout

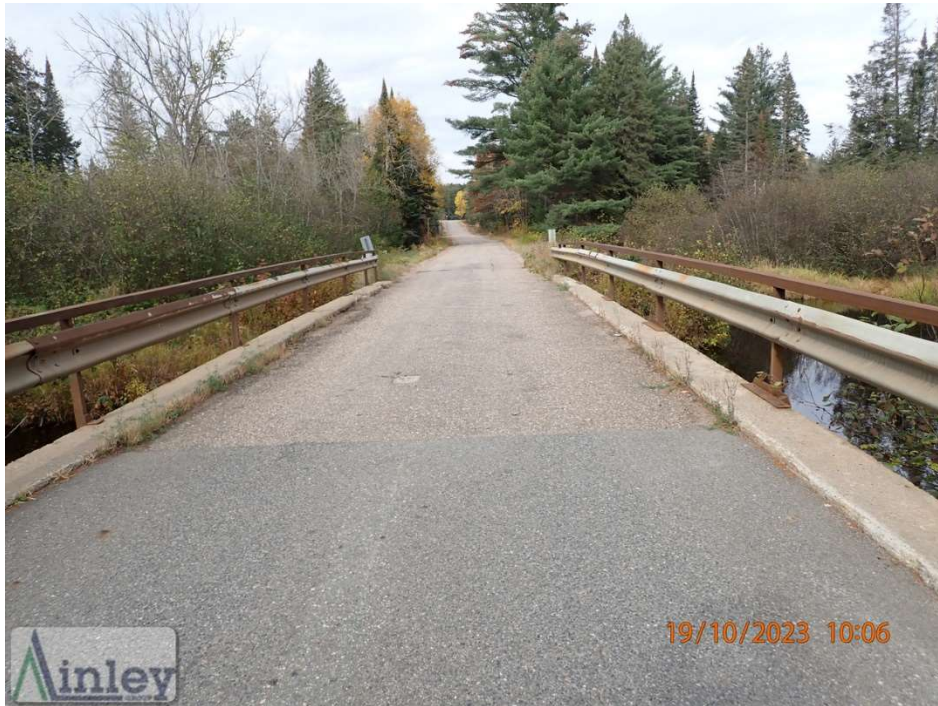
Photo 5: Deck Wearing Surface – Partially Resurfaced, Medium Ravelling and Localized Light Pothole

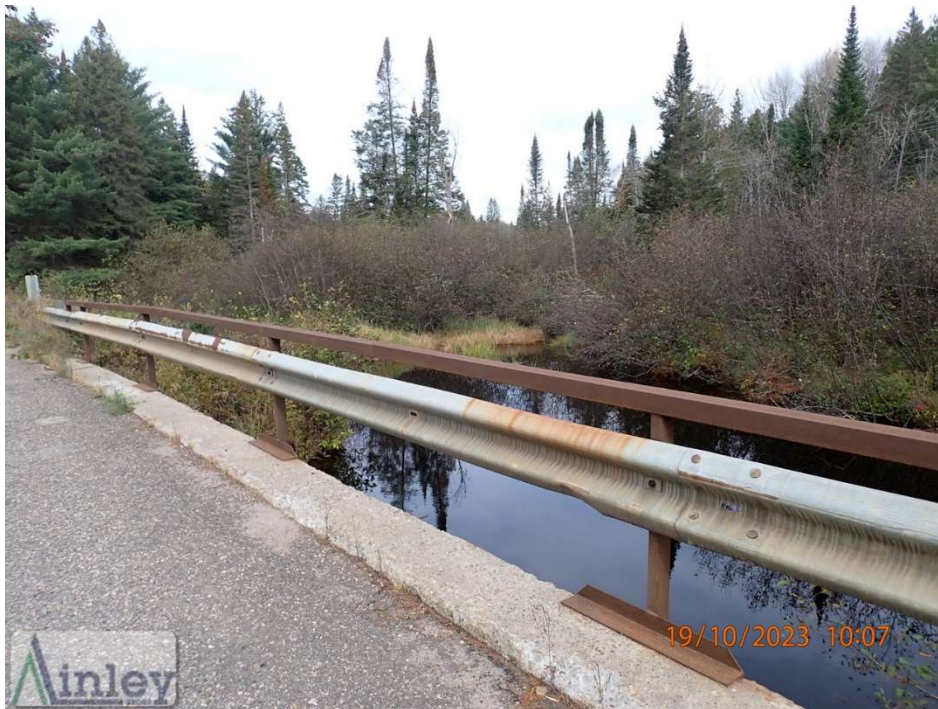
Photo 6: East Railing System – Light Corrosion Throughout Handrail and Posts, Sporadic Light Corrosion and Localized Collision Damage in SGBR

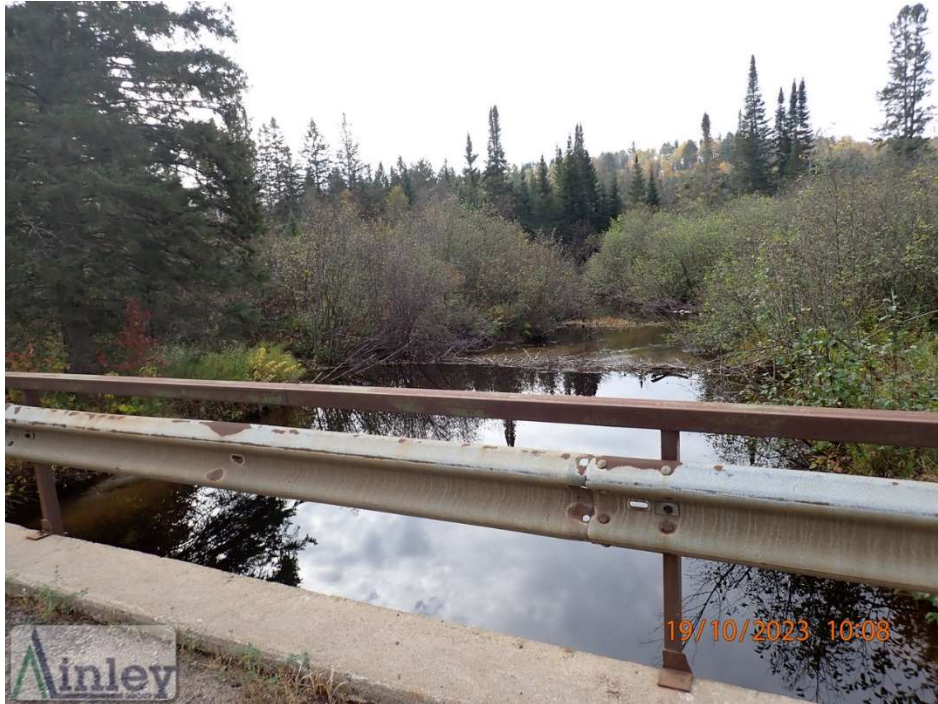
Photo 7: West Railing System – Light Corrosion Throughout Handrail and Posts, Sporadic Light Corrosion in SGBR

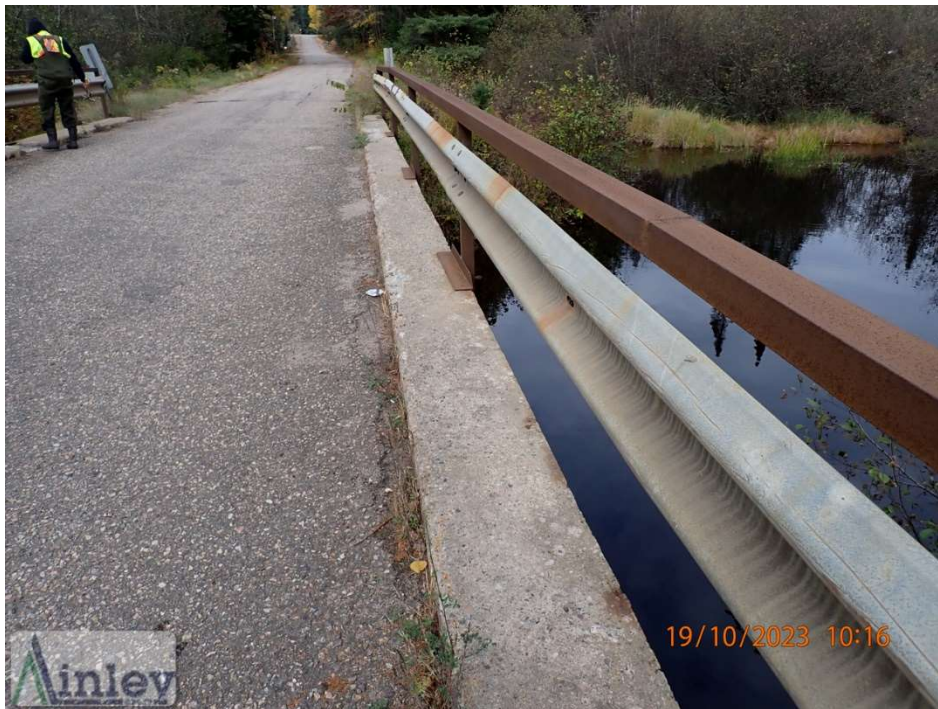
Photo 8: East Curb – Light Scaling Throughout, Localized Light Spalls and Light to Medium Cracks

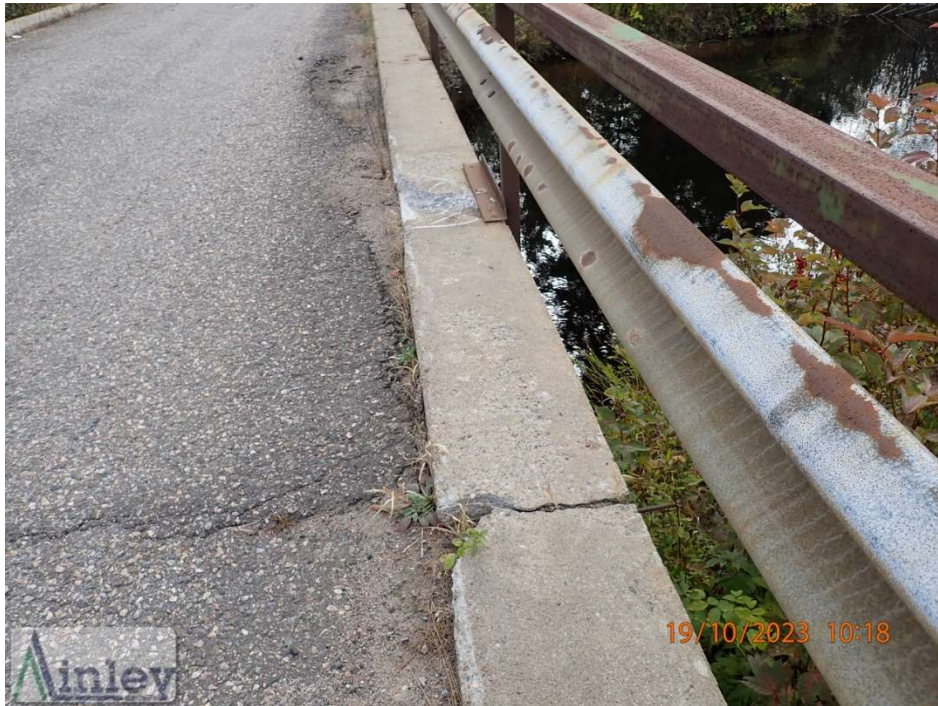
Photo 9: West Curb – Light Scaling Throughout, Localized Medium Spalls and Medium to Wide Cracks

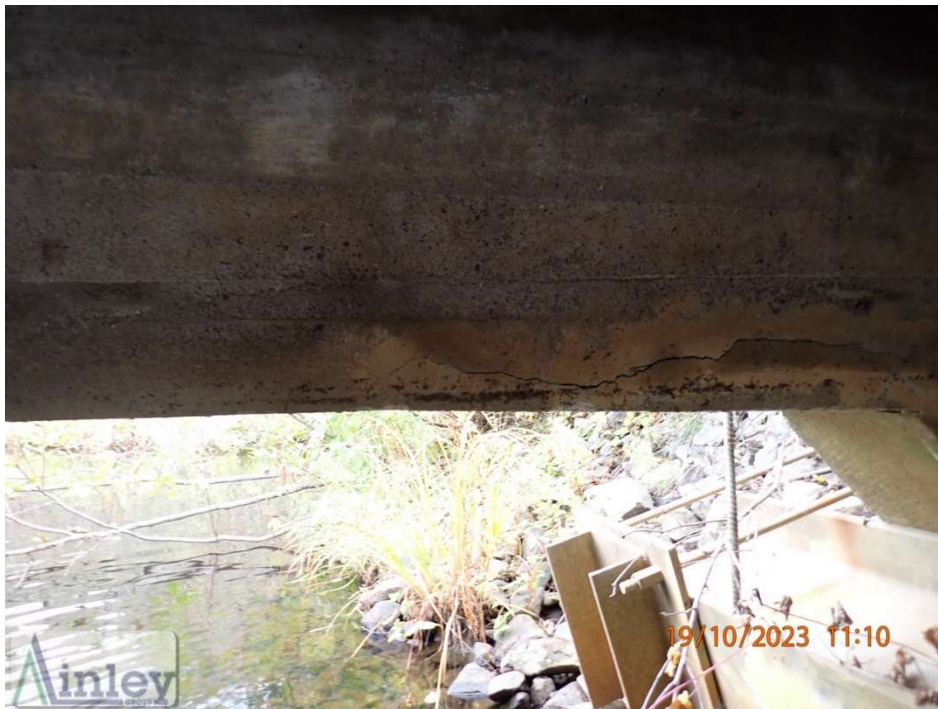
Photo 10: East Exterior Girder – Light Scaling and Wide Horizontal Crack in Interior Face of the Girder

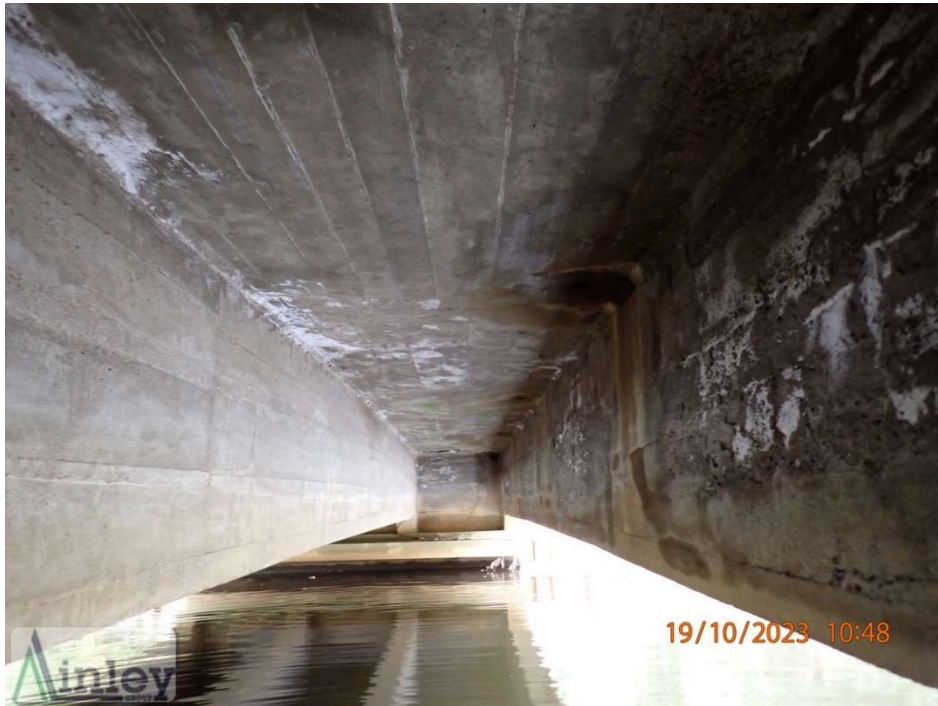
Photo 11: Deck Soffit Looking South – Efflorescence and Moisture Stains, Localized Light Scaling

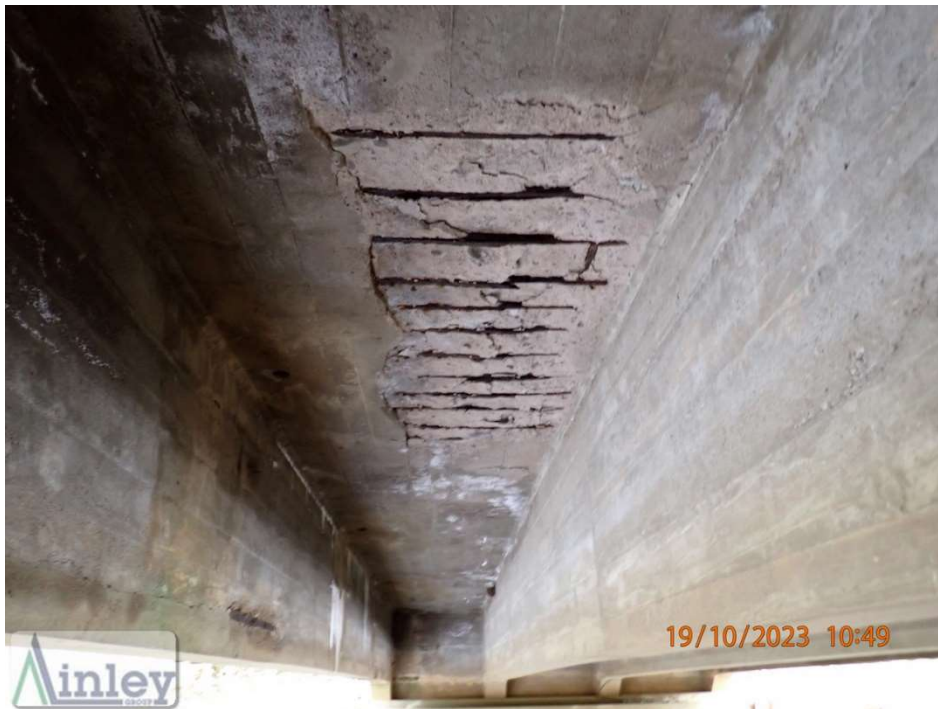
Photo 12: Deck Soffit Looking South – Delamination and Spalling with Exposed Corroded Rebar

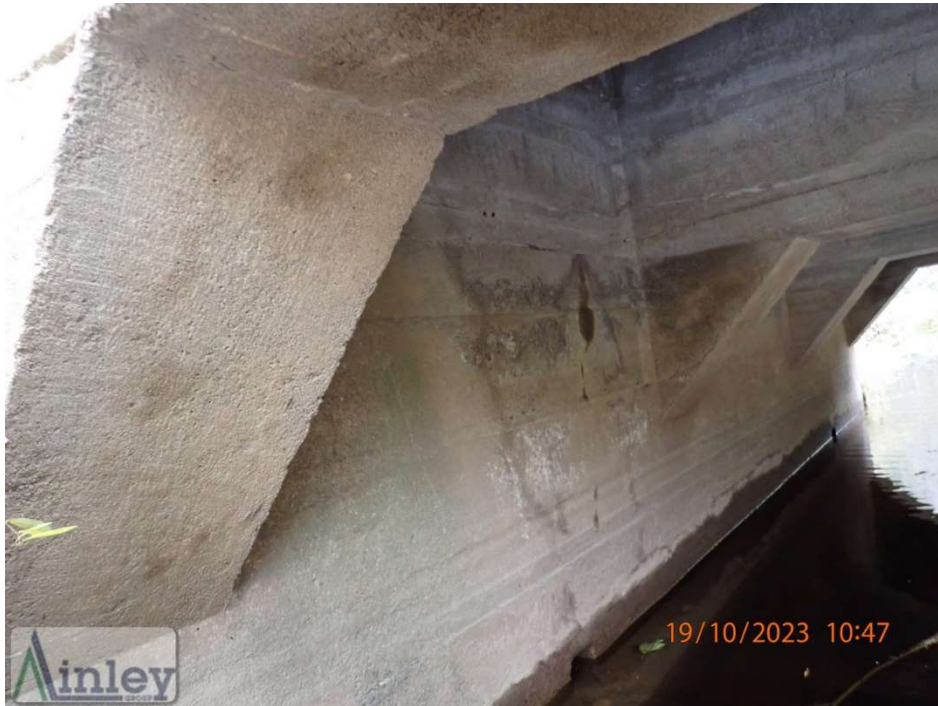
Photo 13: North Abutment Wall – Light Scaling Throughout, Localized Efflorescence and Moisture Staining

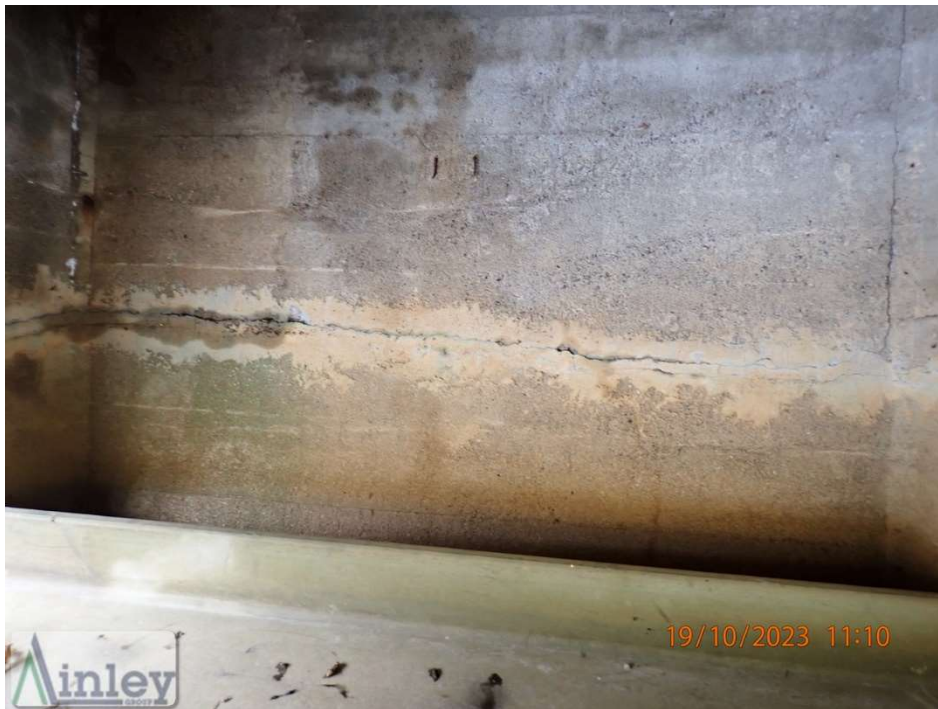
Photo 14: South Abutment Wall – Light Scaling Throughout, Moisture Staining and Localized Wide Crack Throughout the Length of the Wall

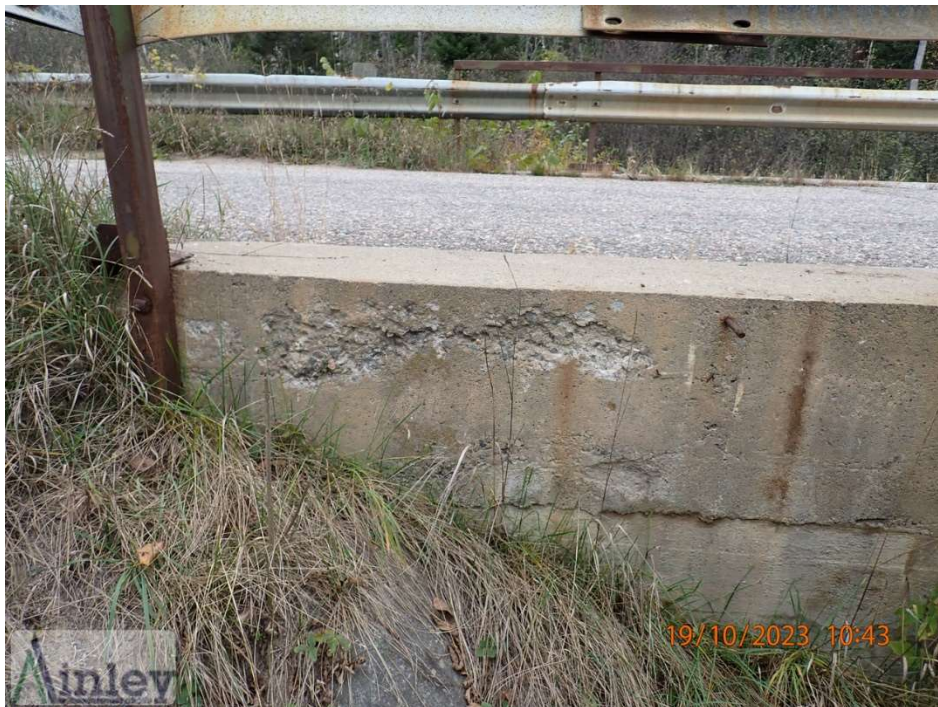
Photo 16: Northwest Wingwall – Localized Medium Spalling, Cold Joint, Moisture and Rust Staining

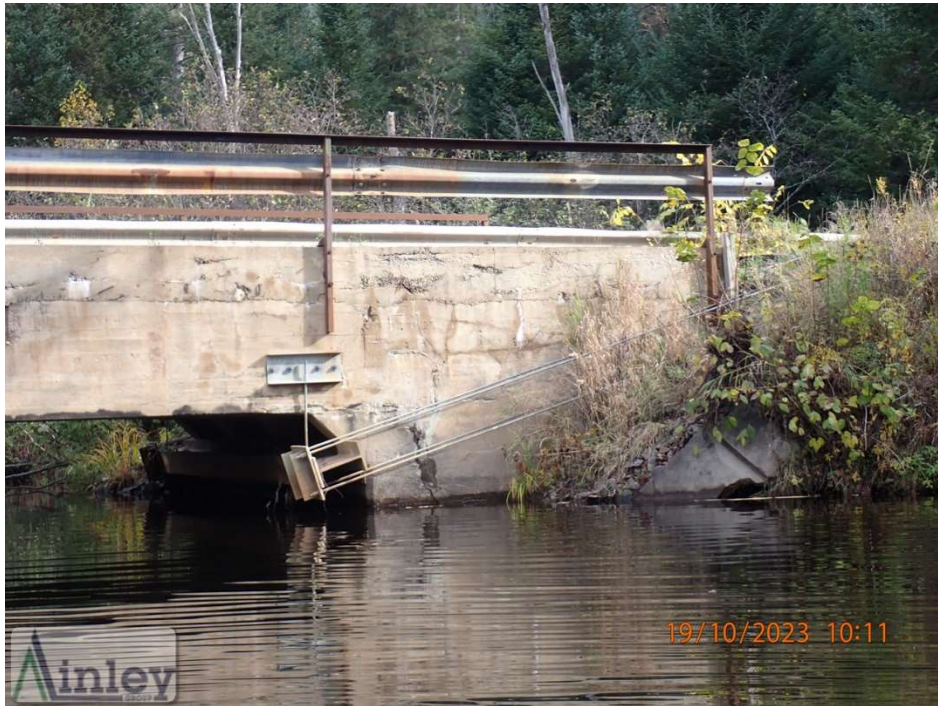
Photo 17: Southwest Wingwall – Localized Medium Spalls, Scaling and Honeycombing, Wide Horizontal and Vertical Cracks with Efflorescence and Moisture Staining Throughout

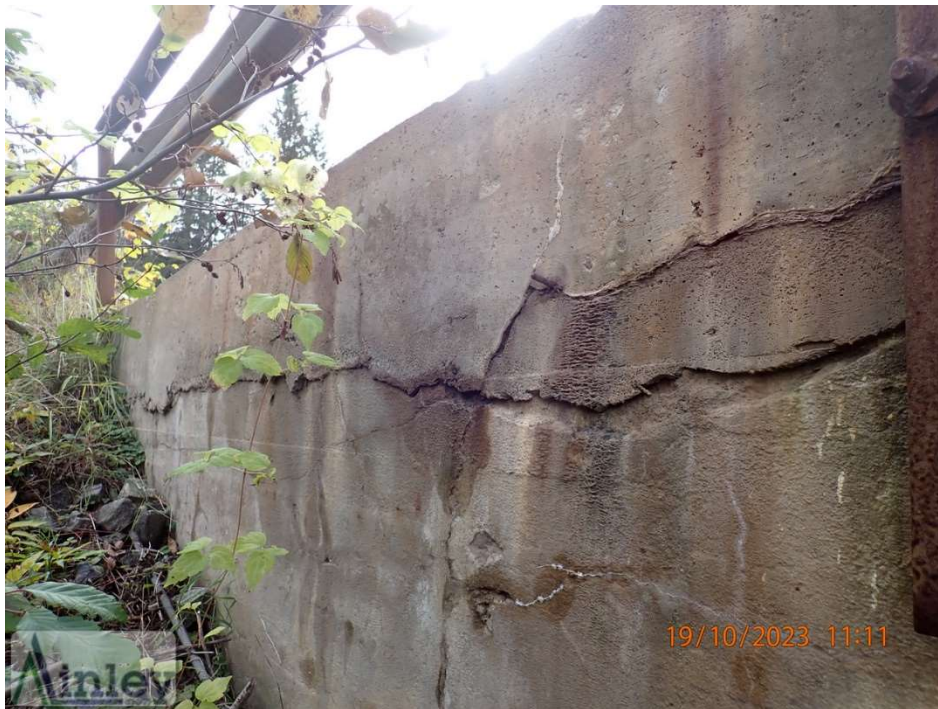
Photo 18: Southeast Wingwall – Wide Horizontal and Vertical Cracks with Moisture Staining Throughout, Cold Joint
