# Hydrogeological Assessment Report, Woodcox Road Subdivision, Bancroft, Ontario.

February 22, 2022

Prepared for:  
2744529 Ontario Inc. (York River Subdivision)

Cambium Reference: 11849-001

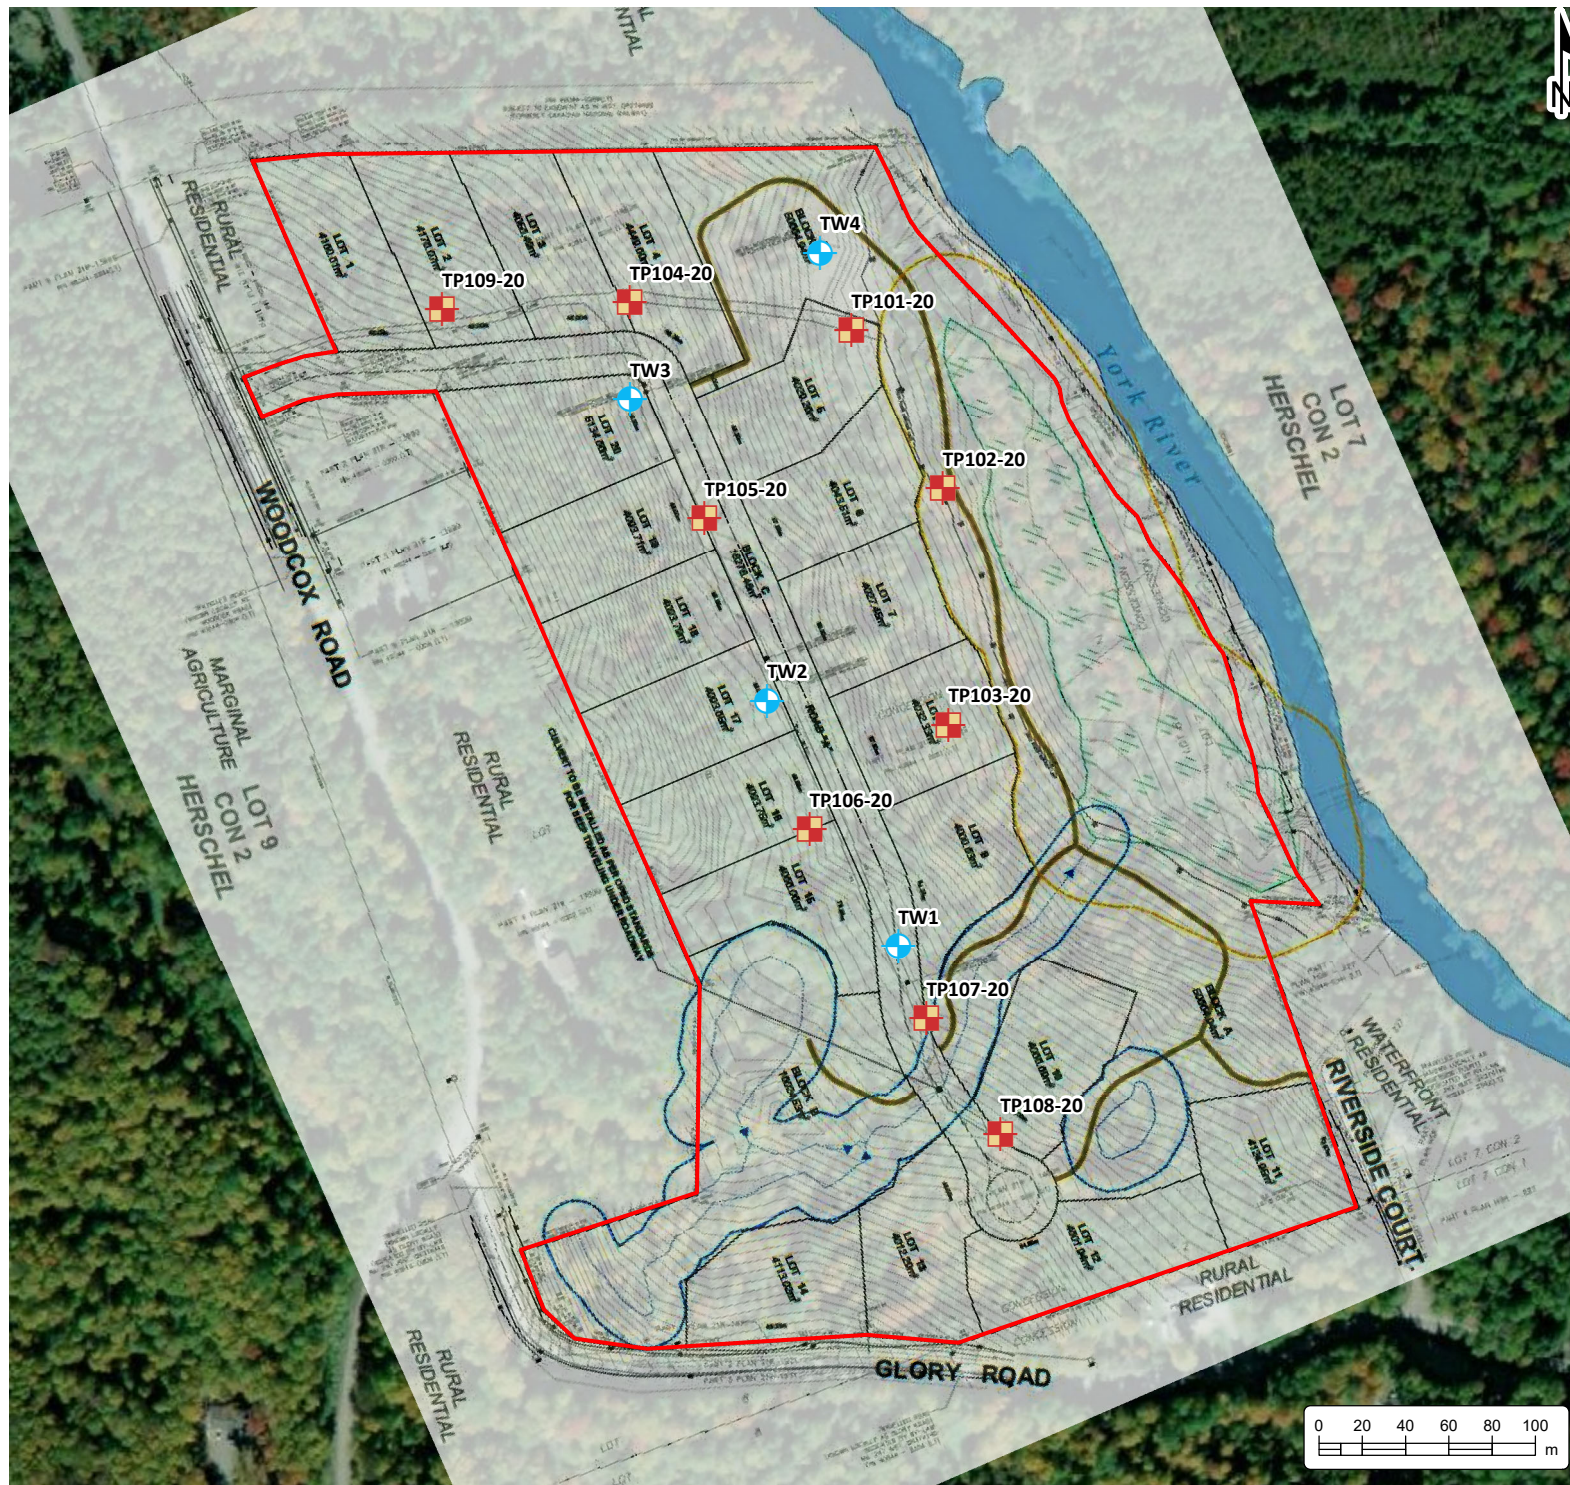
| Figure:<br>3 | |

A total of 9 test-pits, designated as TP101-20 through TP109-20 were advanced throughout the Site. Dynamic probe penetration tests (DPT) were completed at each test pit to determine compaction coefficient of the encountered soil. In addition to DPT's, soil samples were collected from all test pits. Samples were logged for soil colour, texture, structure, moisture content, and consistency/compaction. Each sample was handled only by the technologist using dedicated nitrile gloves. Open test-pits were backfilled with the excavated soils and compacted with the backhoe bucket. The test-pit logs are provided in Appendix B. Test-pit locations is provided in Figure 3.

For all the drilled well locations, the general soil type encountered can be characterized as overburden sediments comprising of brown sand, grey clay, and broken stones ranging in thickness of 7.9 m to 41.1 m and underlain by granite bedrock. The overburden layers indicated increase in depth and thicknesses (7.9 m at TW1 to the south to 41.1 m at TW #4 in the north) from the South to the North of the Site. The depths of the wells ranged from 65.5 mbgs to 73.1 mbgs. The details of test wells are in Table 1 below and the well locations are presented on Figure 3.
