**Environmental Impact Statement (EIS_t)
Proposed Cottage Redevelopment
356A Ponacka Road, Baptiste Lake
Part Lot 30, Concession 6 (Herschel)
Municipality of Hastings Highlands,
County of Hastings**

Project #: 24-3457

August 2024

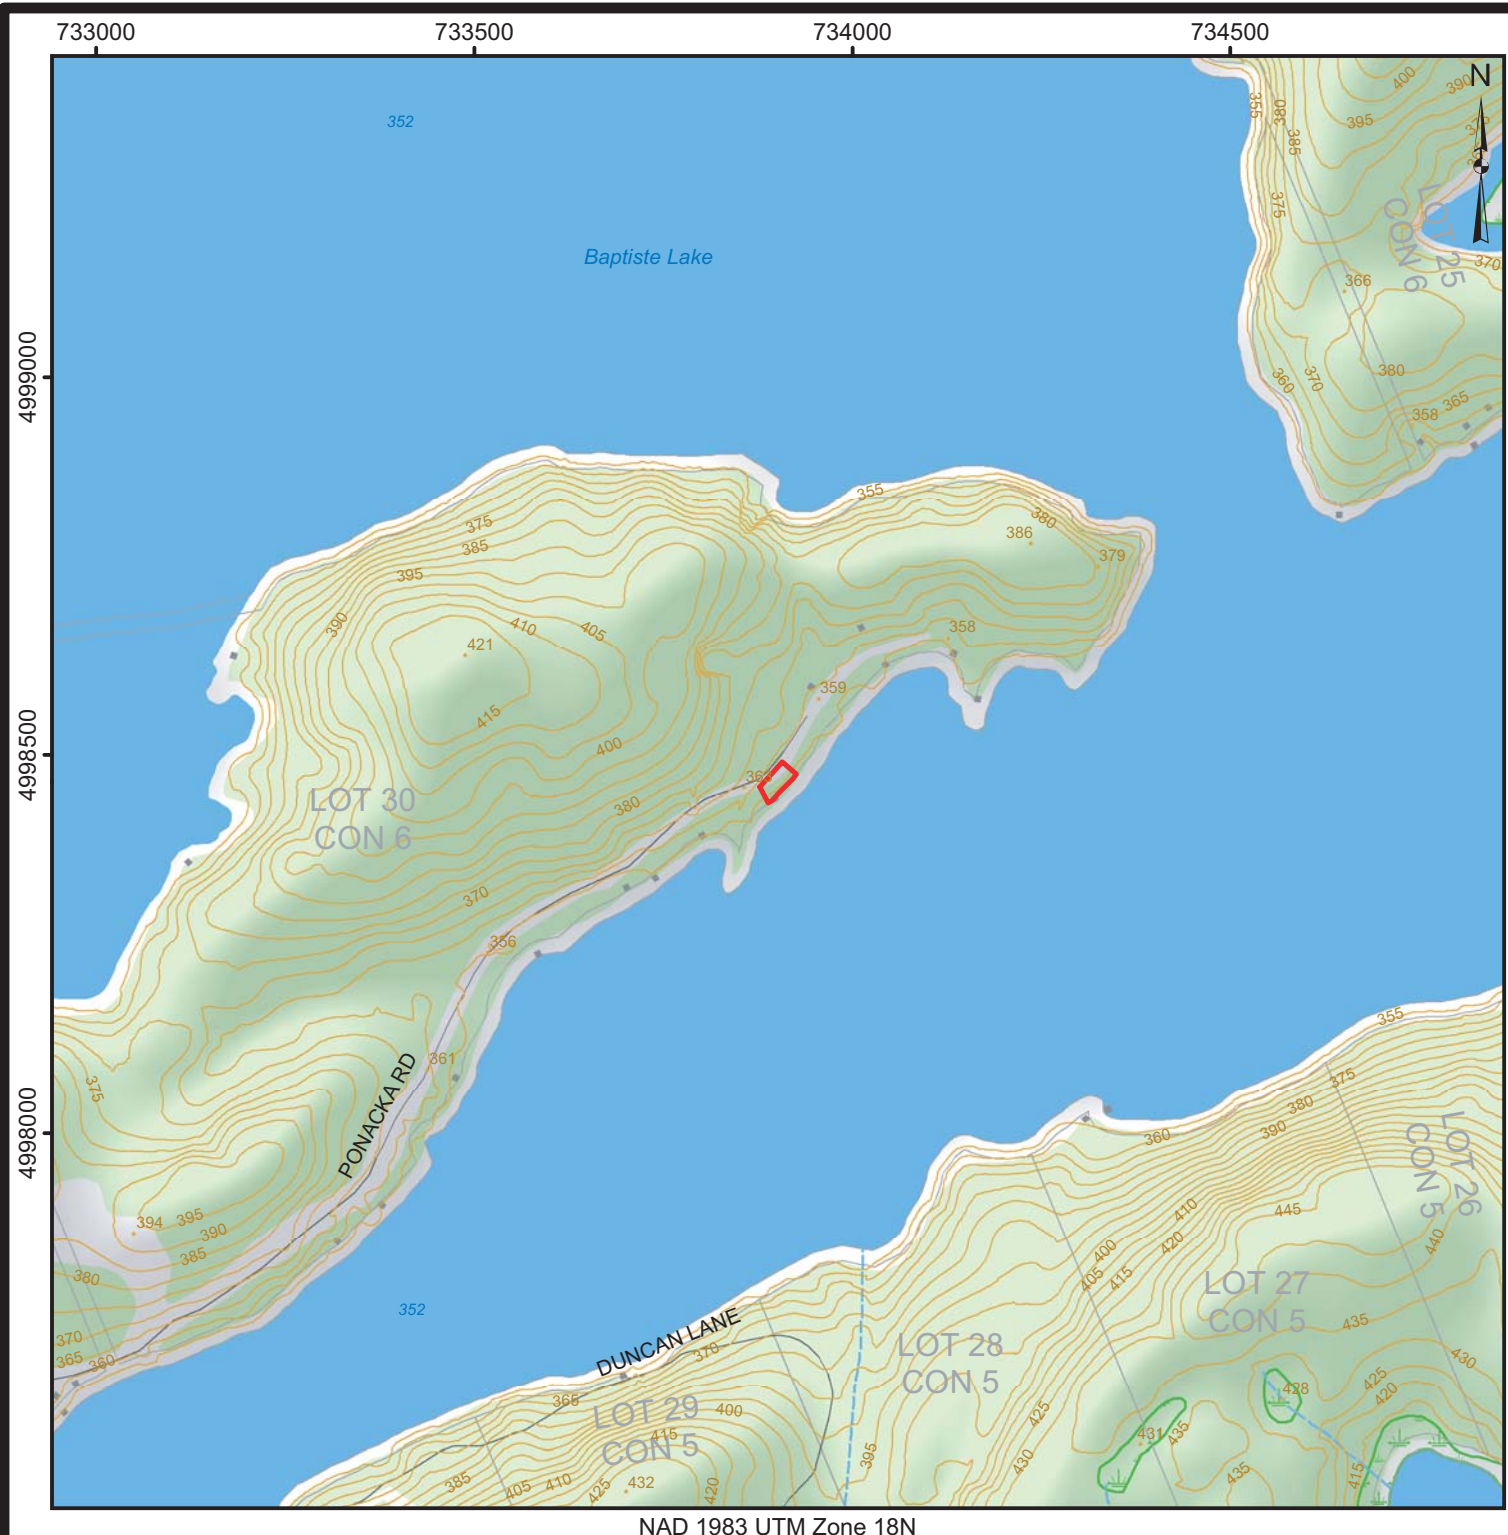
FIGURE NO.
2

As illustrated by Figure 2, the subject property occurs on the southeast facing slope of a significant topographic ridge that forms a southwest to northeast trending peninsula, extending into Baptiste Lake. Although the ridge has a total relief of about 69 m, relief on the subject property is only on the order of 5 m. The ridge is likely a bedrock-controlled feature, typical of the Canadian Shield terrain.

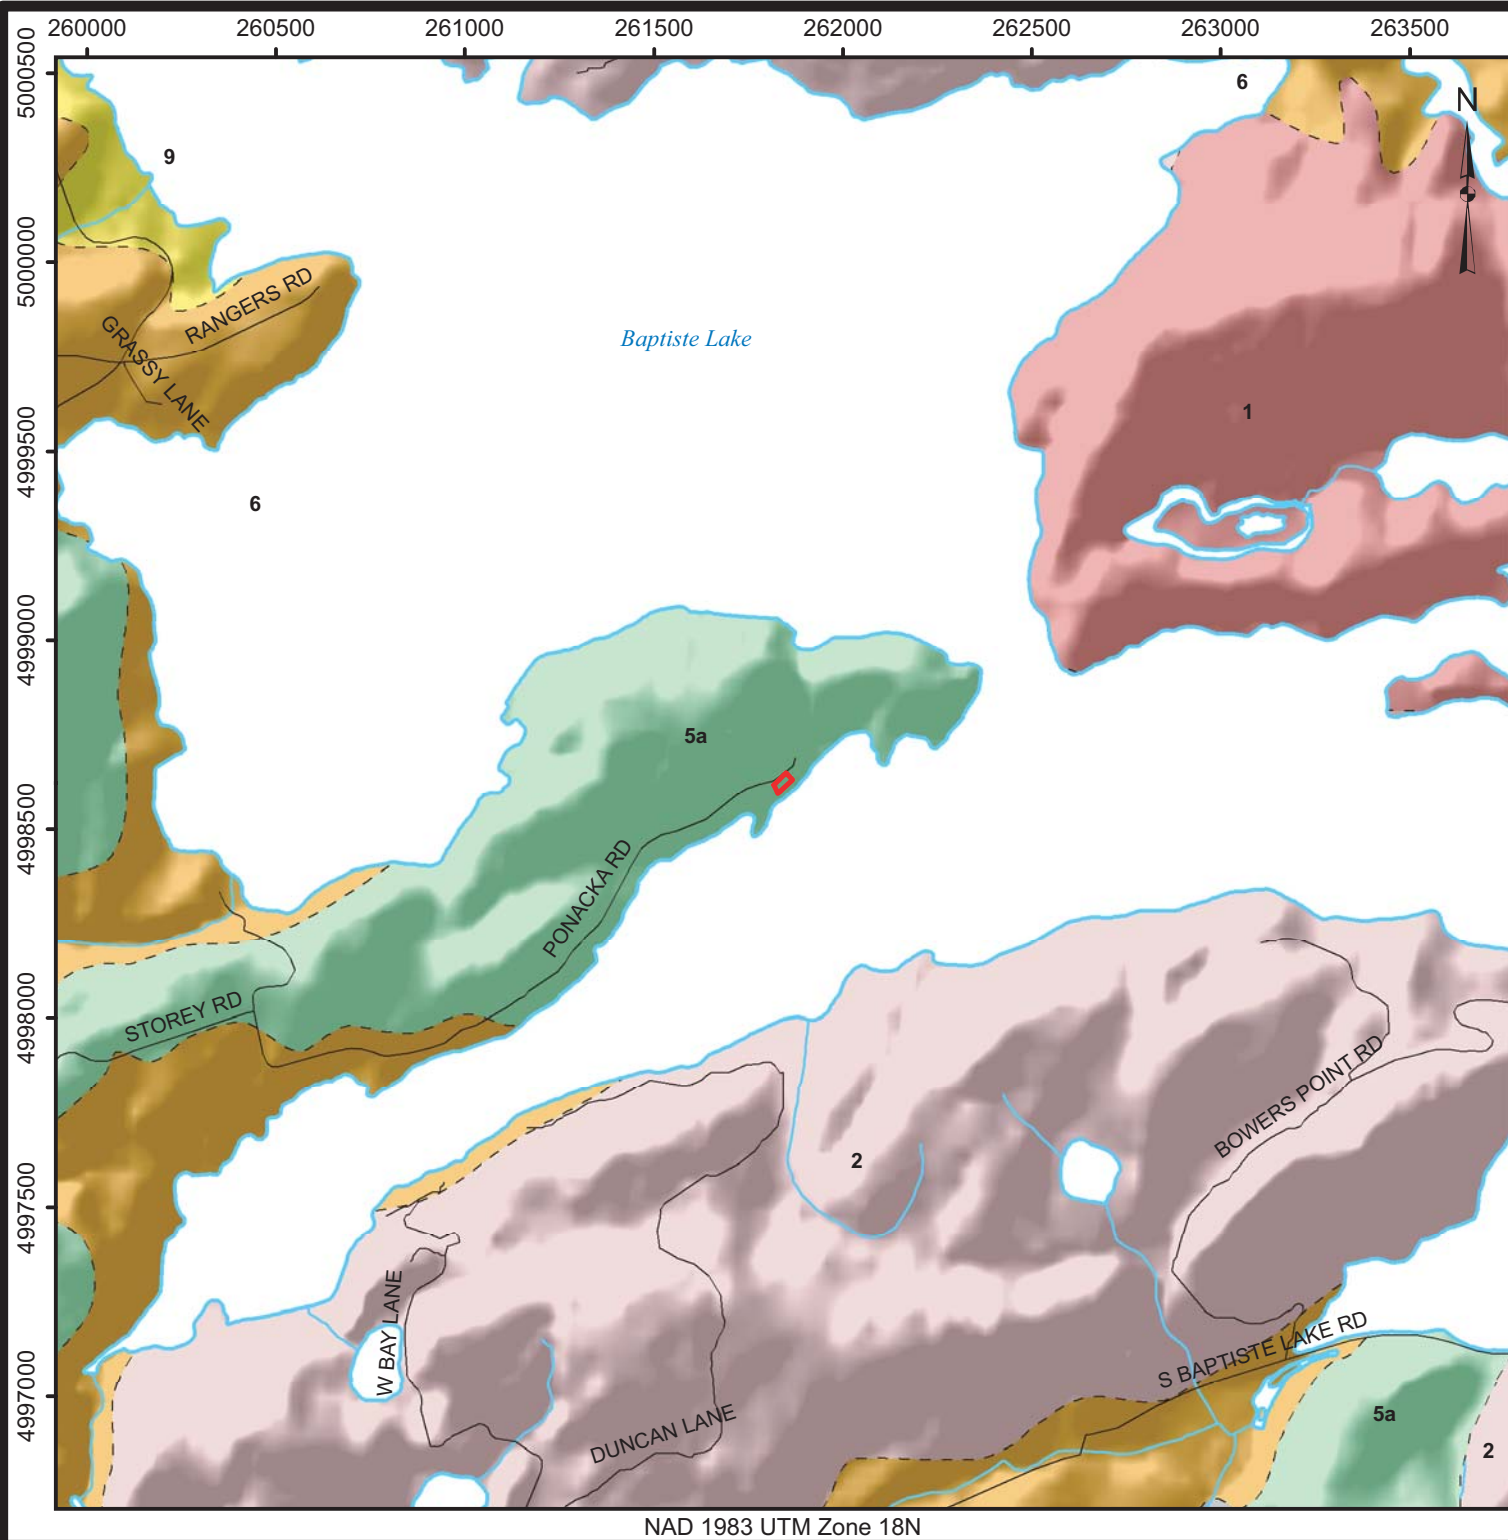
FIGURE NO.
3

As illustrated by Figure 3, the subject property (and the large ridge it occurs within) occurs in an area mapped as being shield derived silty to sand till. This till tends to reflect the local bedrock composition and is believed to be a lodgement type deposit of moderate permeability, adhering to the bedrock surface. Elsewhere in the area, layered ice-contact deposits occur extensively, although none are mapped in the immediate area of the subject site. Small pockets of these highly permeable (sandy) soils could, however, be present locally. In contrast, other bedrock-controlled ridges in the area are mapped as having minimal overburden cover.

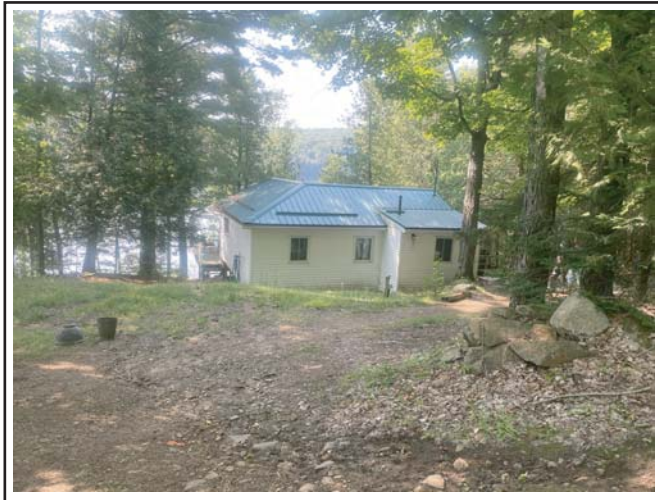
Photo A: photo of the rear part of the building, taken from the road looking at the area where the new building would flow over into.

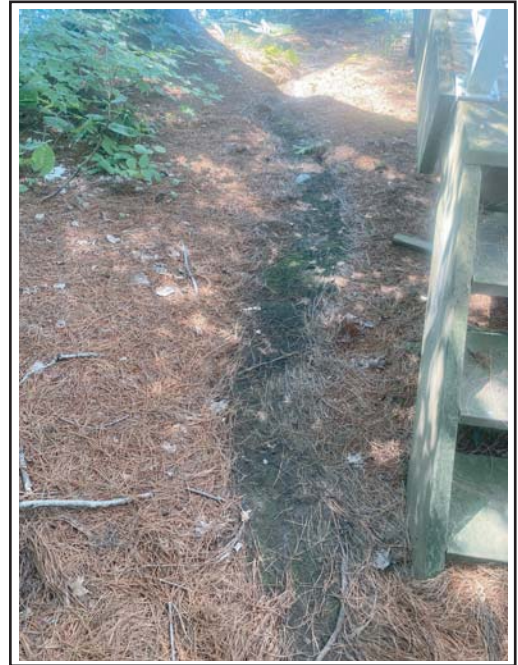
ORE staff also noted that there has been some minor erosion-sedimentation along the east side of the existing cottage. The contractor should determine what steps will be necessary to better contain/prevent any eroded materials from the hillside from entering the lake.

Photo B: minor erosion down the west side of the existing cottage.

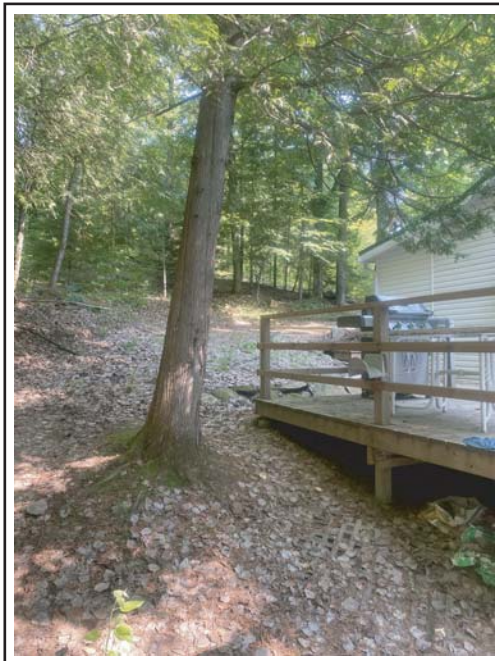
Photo C: photo looking at the rear of the building, the septic field is in the background of the photo.

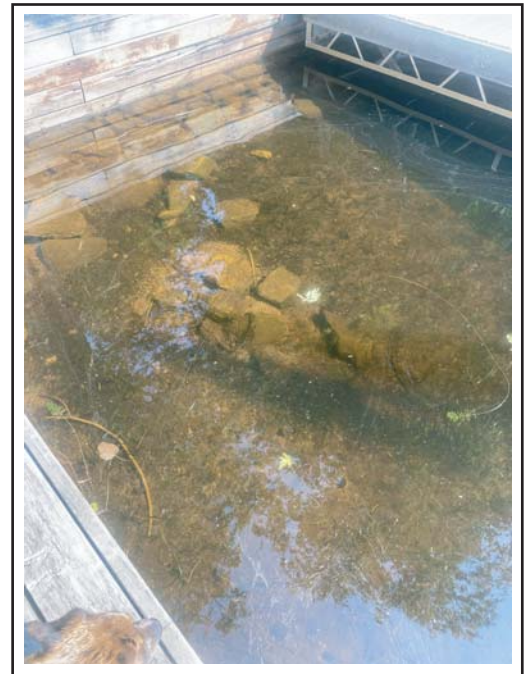
ORE staff observed approximately six (6) Centrarchid spawning redds in the near-shore environment on either side of the dock during the inspection. It was not spawning season for Centrarchid species, however, some adults were observed utilizing the dock as cover.

Photo D: photo of the littoral zone conditions where some of the Centrarchid spawning occurs.

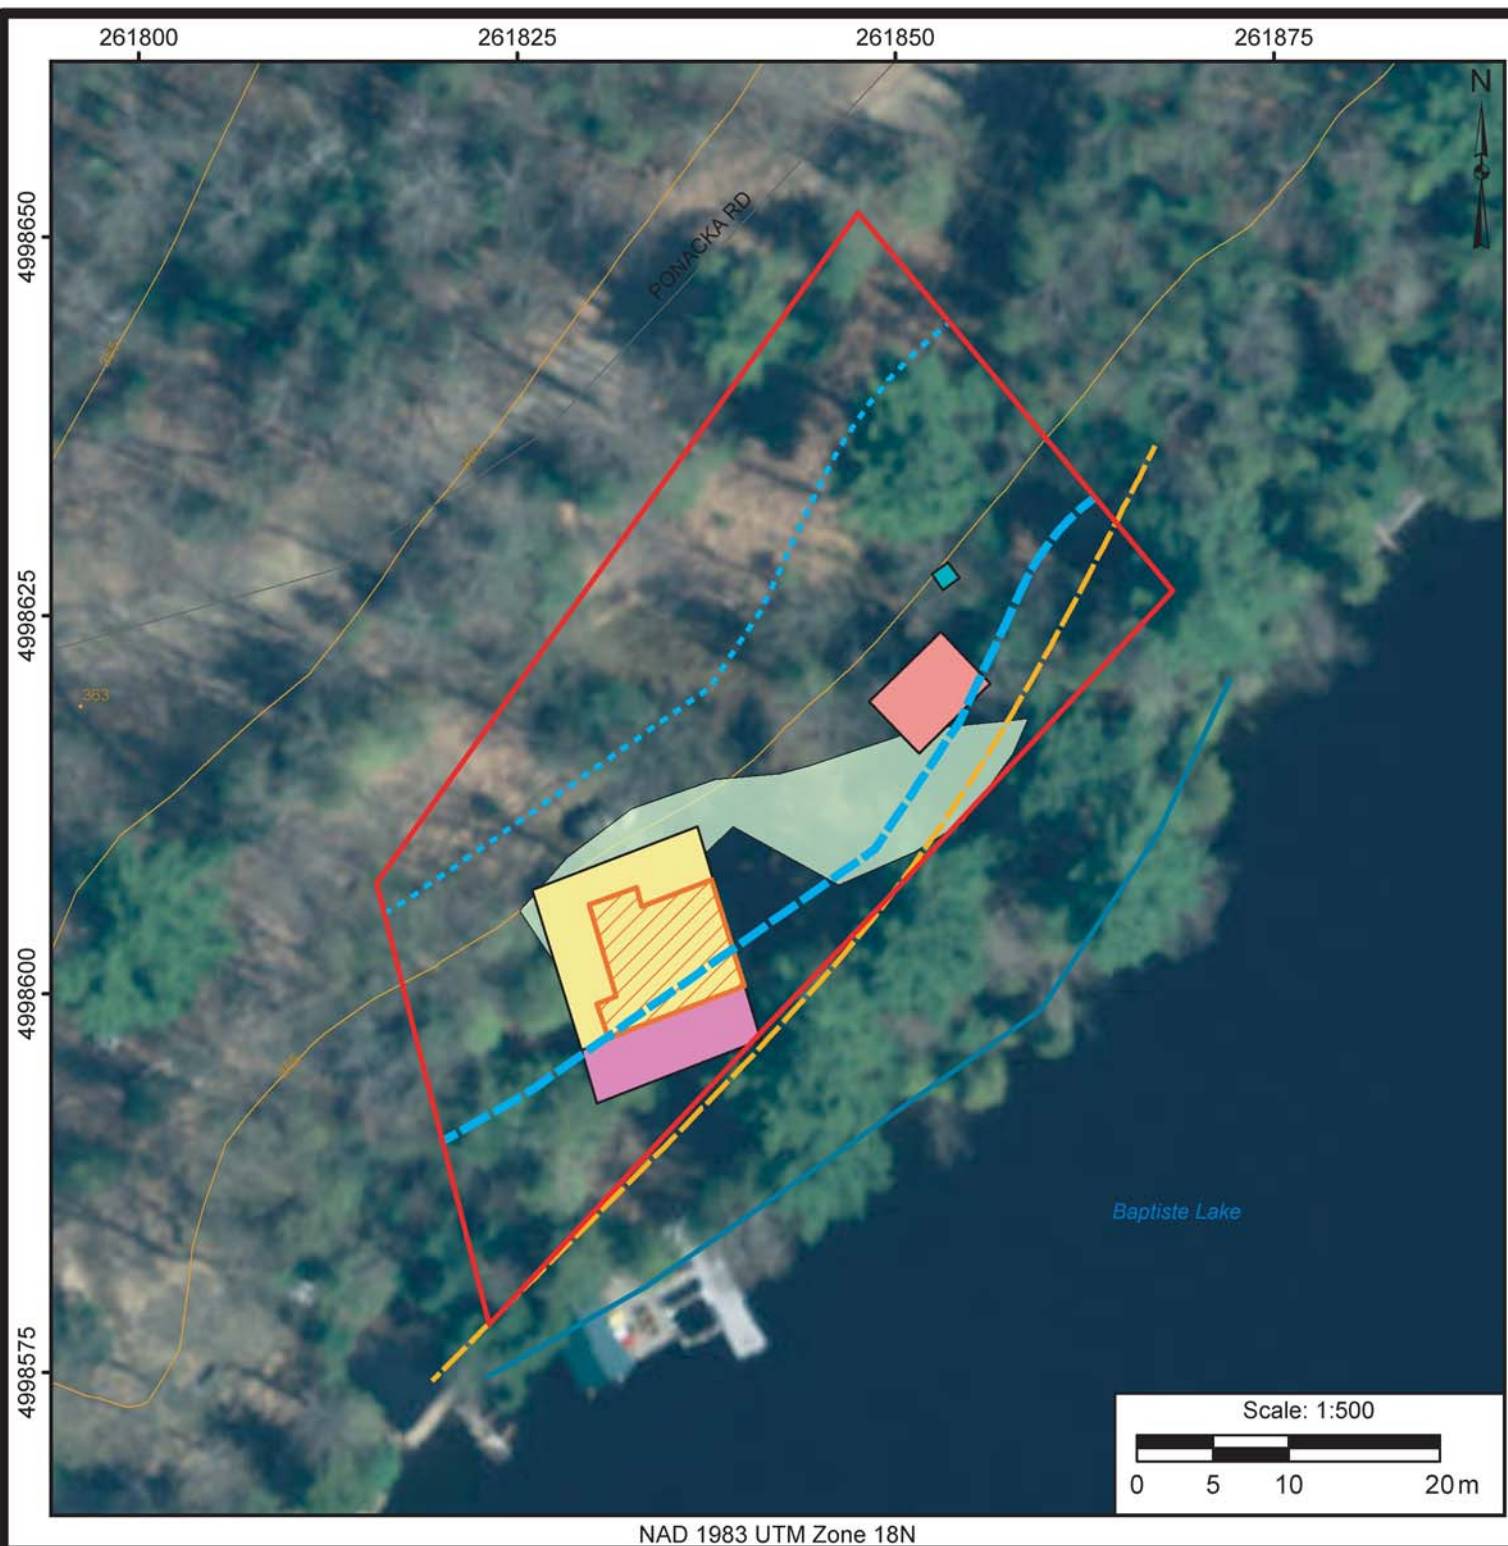
- Property Boundary (Richmond Surveying, 2024)
- Existing Residence (Richmond Surveying, 2024)
- Proposed Residence (Ponaka INC, 2024)
- Existing/ Proposed Septic Area: As Provided by Proponent (Ponaka INC, 2024)
- Outhouse Location (Richmond Surveying, 2024)
- Proposed Deck (Ponaka INC, 2024)
- Open Area (ORE)
- Inner Limit of Shore Road Allowance (Richmond Surveying, 2024)
- Road
- Contour (5 m Intervals)
- Shoreline
- Shoreline Buffer 30m
- Shoreline Buffer 15m
- Spot Height (m asl)

- The proposed plan for the new cottage will not require any substantial site alterations and the footprints of these will be similar to what is existing. It is ORE's recommendation that the building envelope/disturbance area occur no closer than the existing/proposed southerly limit of the building (excludes the proposed deck). Although the redevelopment/site alterations under the PPS definition are to occur within 30 m of the lakeshore, there is an existing use in this area and impacts can be mitigated provided the recommendations are adhered to with respect to stabilizing the areas between the lake and proposed cottage, in addition to installing the silt fence perimeter around the disturbed area as illustrated on Figure 6.

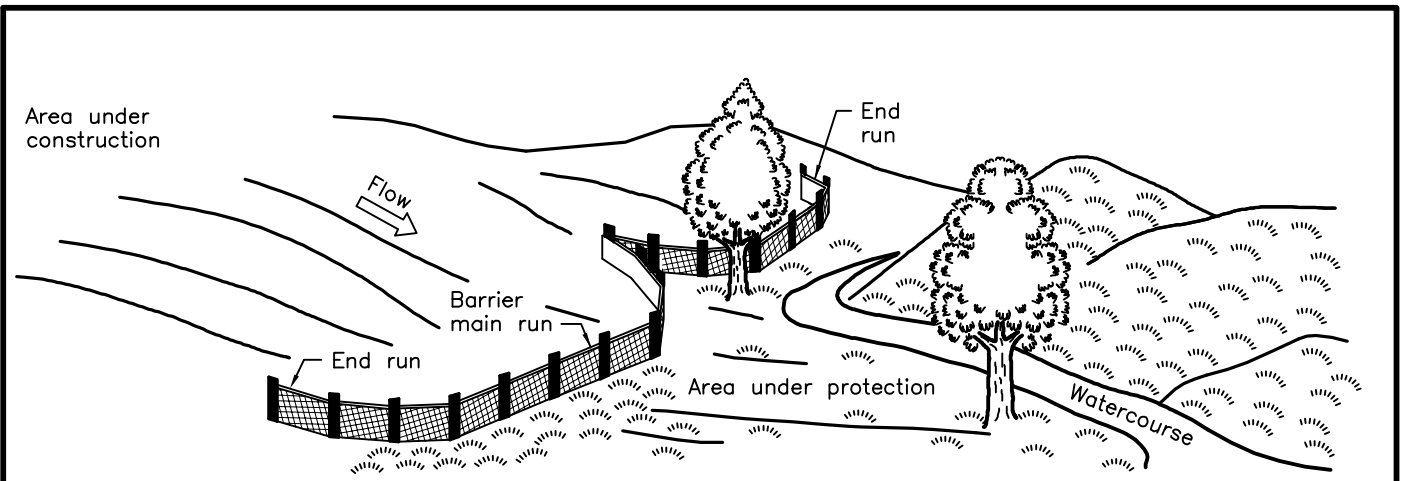
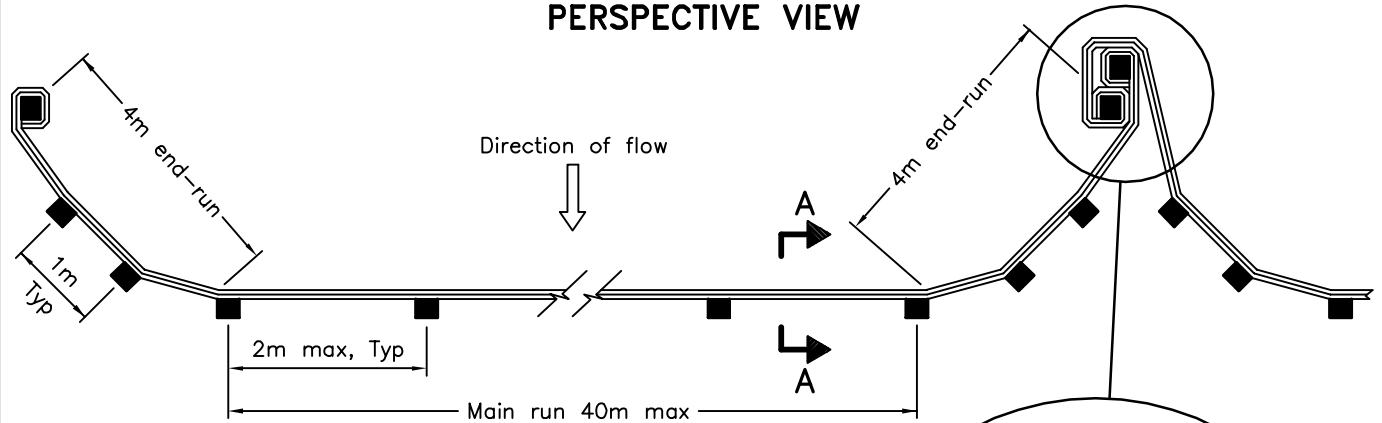
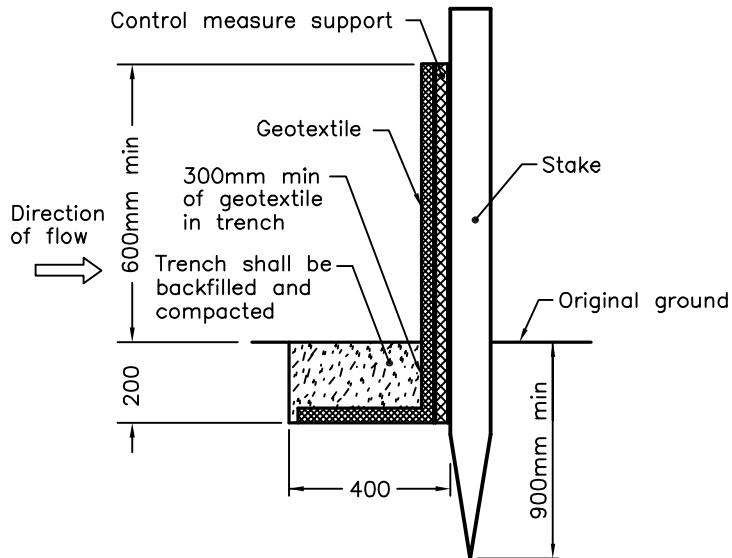
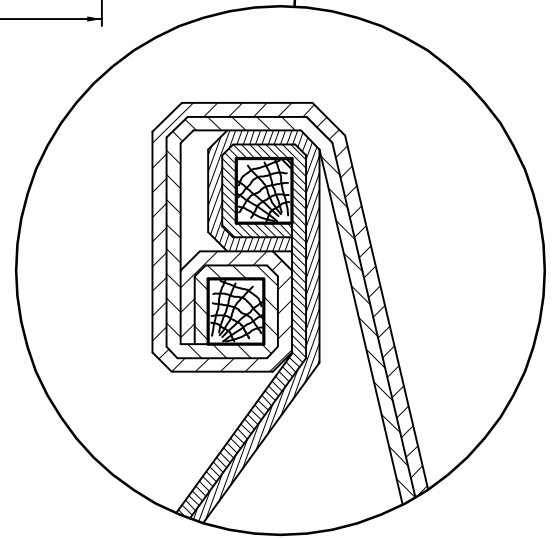
OPSD Heavy-duty Silt Fence

PERSPECTIVE VIEW

PLAN

SECTION A-A

JOINT DETAIL

The contractor can open the silt fence along the north corridor to allow access to the building site and continue with the day-to-day construction activities. The heavy-duty silt fencing will ensure that any loose/unconsolidated materials do not migrate beyond the cordoned construction area, thereby protecting Baptiste Lake.

- As there is a potential for SAR turtles to occur within Baptiste Lake waterway (e.g., Snapping Turtle, Blanding's Turtle, etc.), the heavy-duty silt fence will also serve as a turtle exclusion fence, as recommended by the Ministry of Natural Resources and Forestry (MNR). Light-duty silt fence is not considered an acceptable exclusion fence material, as large turtles such as Snapping Turtle, can dig beneath the fence or potentially push the fence over and enter the construction zone. Nesting turtles and/or their eggs can be damaged by construction equipment. The fence is there to prevent this from happening.
